## STRUCTURE AND MECHANICAL PROPERTIES OF STEEL STEAM TURBINE ROTOR BLADES AFTER OPERATION

PETRO SOLOVEI<sup>1</sup>, IVAN TSYBAILO<sup>1</sup>, SOFIIA KRECHKOVSKA<sup>2</sup>

1. Karpenko Physico-Mechanical Institute of NAS of Ukraine
2. Lviv Polytechnic National University

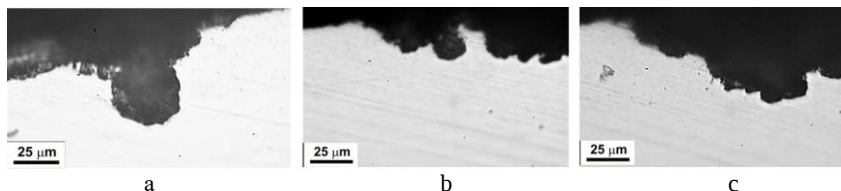
**Results.** Corrosion damage to different depths was found on the cross-section of the blade, located below its operational fracture surface (Fig. 1). Their maximum depth was  $\sim 50\text{ }\mu\text{m}$ . The density of these damages was less, but they were deeper near the leading edge of the blade (Fig. 1, a). Their geometry indicates the corrosive nature of their occurrence.

Fig. 1. Defects from the convex surface of the fractured blade, revealed on the cross-section at the distance 1.5 mm (a), 5  $\mu\text{m}$  (b), and 8 mm (c) from the leading edge.

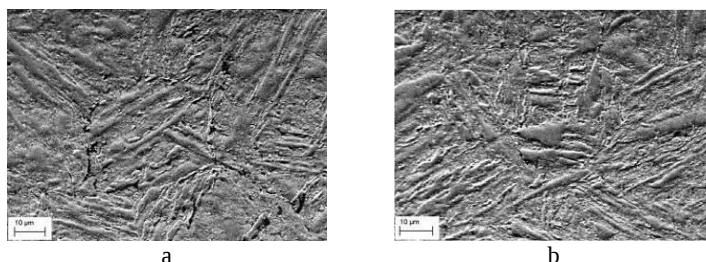
In the cross-section of the blade, an almost uniform structure of highly tempered martensite (type tempering sorbite) was found, the packets of which were located within the former austenite grains (Fig. 2). In the steel structure, small carbides were observed along the packet's boundaries of highly tempered martensite and somewhat larger (up to  $1.5\text{ }\mu\text{m}$ ) along the boundaries of former austenite grains (Fig. 2, a, b). They were considered to be a factor in weakening cohesion both between grains and between packets of highly tempered martensite. Operating conditions, namely the presence of condensate with corrosive-active impurities, rotor shutdown with blade overload, and steel hydrogenation, are contributing to the decohesion of carbides from the matrix and the formation of deep corrosion pits near the leading edge of the blades, from which could nucleation corrosion-fatigue cracks.

Fig. 2. Typical structure of 15Kh11MF steel in the cross-section of the blades at the distance 1.5 mm from the leading edge near its concave (a) and convex (b) surfaces.

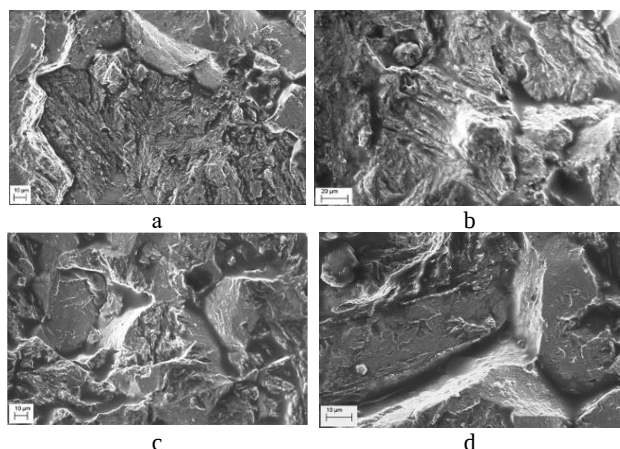
Micro fractographic analysis of the operational fracture of the blade revealed that several cracks initiated from corrosion damage on the concave surface near the leading edge of the steam turbine blades. They extended to the entire cross-section of the blade during high-cycle corrosion fatigue and formed typically for such steels an inter- and transgranular relief fracture (Fig. 3, a). The connection of the intergranular relief of fracture surface with the structure of steel was noted (Fig. 2, Fig. 3, b). As the propagation of fracture over the entire cross-section of the blade, the role of grain boundaries increased, which was manifested by an increase of the area of the intergranular fracture. The

intergranular fracture was observed within large grains with unfavorably oriented (relative to the main direction of corrosion fatigue crack growth) packets of highly tempered martensite. At a higher resolution, secondary cracking along the grain boundaries was observed, which clearly outlined intergranular facets (Fig. 3, c, d). It was found that the farther from the convex surface into the body of the blade, the brighter these features were. A mixture type was preserved throughout the further propagation of the fracture in the blade cross-section until the appearance of fatigue macro marks on the fracture, concentrically located relative to the leading edge of the blade.

Fig. 3. Peculiarities of the fractures surface relief in the centers of initiation of blades fracture from their convex surface.

Therefore, the fracture of the rotor blades is due to the corrosion-fatigue crack growth from the leading edge of the blade with its propagation into its entire cross-section due to high-cycle fatigue.
