## ANALYSIS OF THE STRUCTURAL AND MECHANICAL STATE OF HEAT-RESISTANT STEEL OPERATED IN STEAM TURBINE BLADES

The structure and mechanical properties of the steam turbine blade steel were analyzed. It was found that the plasticity characteristics and impact toughness values of operated steel were slightly lower than the regulated ones. The corrosion-active non-metallic inclusions were revealed in the steel structure, increasing the corrosion damage of steel during operation under technological conditions.

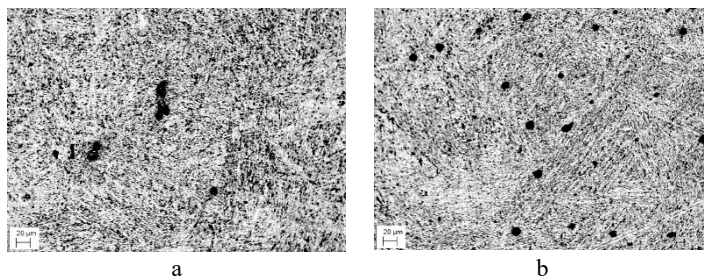
The particle-dispersed structure of the steel of the analyzed blade (as a mechanical mixture of alloyed ferrite and fractional carbides) was preserved after high output and three-phase high-temperature operation morphological bond with a typical orientation for martensite packets in three directions and changes from grain to grain (Fig. 1). The structural peculiarity of steel is the number of large (up to 5–7 microns, and sometimes up to 30 microns) non-metallic inclusions, randomly distributed in both cuts of the blade. In the transverse section, their volume on a single section surface was greater in the later section (Fig. 1). Despite their smaller size, they were located more densely, which significantly weakened the transverse section of the blade feather.

Micro-X-ray spectral analysis established that these are corrosion-active non-metallic inclusions (wt.%: 33.89 C; 23.96 O; 4.79 Al; 0.99 Si; 0.56 Ca; 10.64 Cr; 25.17 Fe), which are dangerous during operation in hydrogen-containing environments, since they can increase the rate of local dissolution of the matrix in their vicinity by orders of magnitude. These inclusions significantly worsen the corrosion resistance of steels and increase their susceptibility to pitting (as potential foci of fatigue crack initiation). The role of this dangerous aspect of

structural degradation of steel will constantly increase with increasing service life and will worsen the performance of blades during their operation. After all, due to the loss of cohesion of these inclusions with the matrix in the blade cross-section, a developed network of cavities was formed as structural stress concentrators. Under the influence of high cyclic loads during the operation of the blades in the turbine, the membranes between these cavities will collapse, which will inevitably result in the destruction of the entire blade cross-section. Therefore, when justifying the loading parameters of the blades, it is important to conduct an input control of the structural features of the steel for its compliance with the requirements for the presence of non-metallic inclusions.

Fig. 1. Microstructure of steel 20X13 working blade at the longitudinal (a) and transverse (b) sections of the blade.

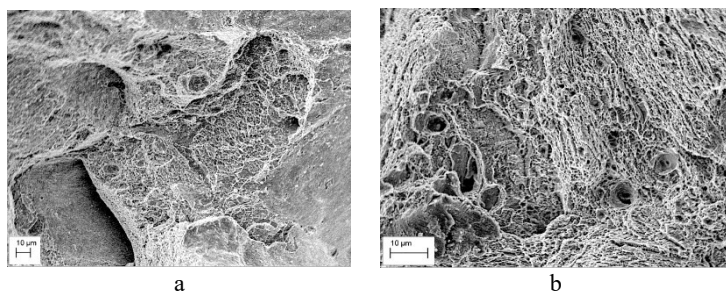
Fig. 2. Microfractograms of the fracture of a smooth specimen made of blade metal, tested by tension in air.

Fractographically, on the fractures of smooth samples from the blade, tested for tension in air, against the background of large areas of small dimples of detachment formed on carbides in the steel structure, significantly larger ones (10–15  $\mu\text{m}$  in size) were found, which were attributed to those formed on non-metallic inclusions (Fig. 2). Often in their vicinity were observed areas of brittle quasi-cleavages, which were considered evidence of the embrittlement effect of hydrogen accumulated in the cavities around large inclusions (Fig. 2b).
